# WARTIME REPORT

PRELIMINARY REPORT ON FLIGHT TESTS OF AN  
AIRPLANE HAVING EXHAUST-HEATED WINGS

By Lewis A. Rodert, William H. McAvoy, and  
Lawrence A. Clousing

Ames Aeronautical Laboratory  
Moffett Field, California

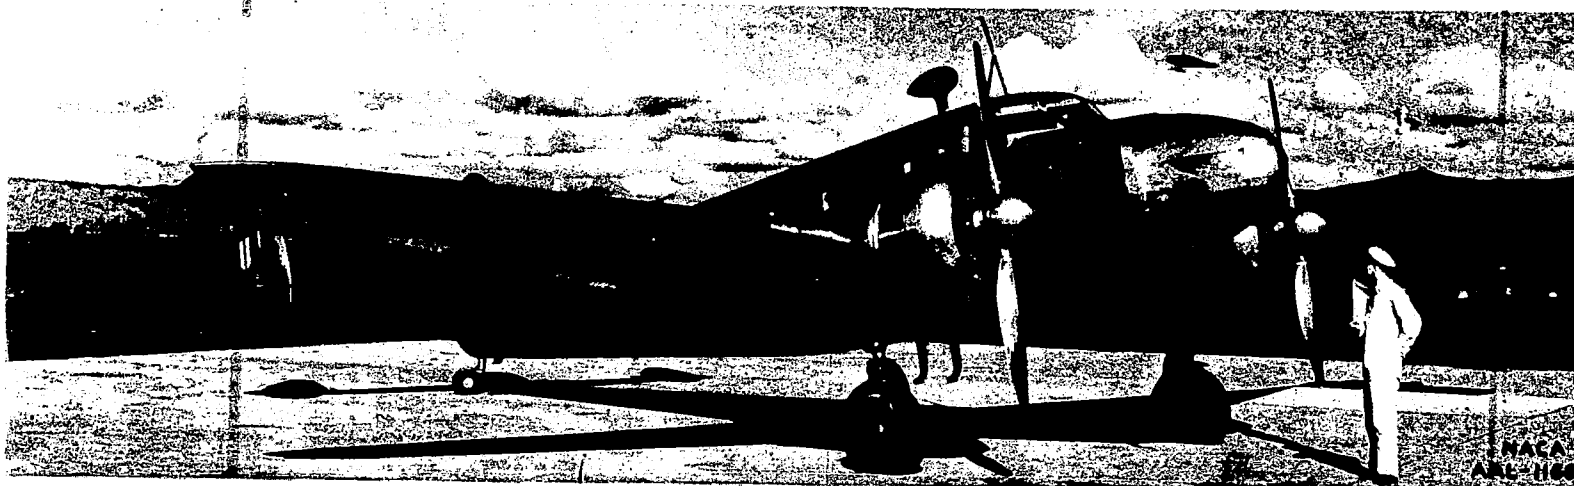
Figure 1. - Lockheed 12-A airplane. Alterations were made to a standard commercial model which include provisions for heating the wings with exhaust gas, and the windshield with heated air.

The Lockheed 12A airplane (fig. 1), in which the research was conducted, was equipped with two Pratt and Whitney 450-horsepower Wasp Junior engines, and 8-foot 10-inch diameter constant-speed propellers. The wings were heated by passing all or part of the engines' exhaust gas through tubes along the inside of the wing leading edges. The quantity of exhaust gas passed through the wing was controlled from the pilots' cockpit. The exhaust gas was discharged from the wing tube at the wing-tip joint into a tip shroud, and from there to the atmosphere. Figures 2, 3, 4, 5, 6, and 7 show details of the exhaust heating system in the wing.

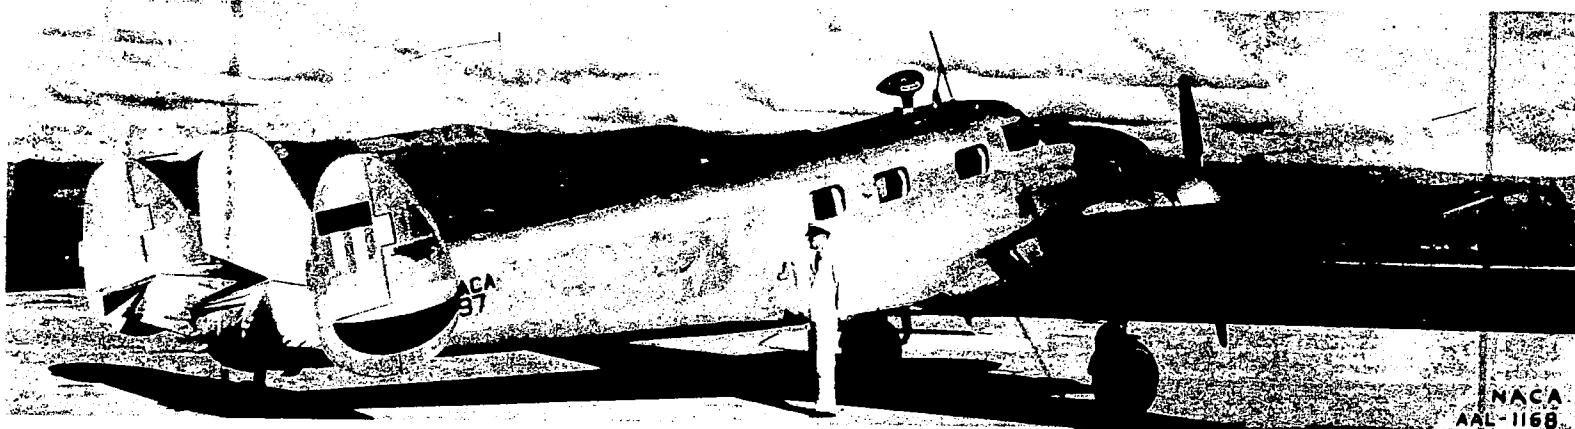
Figure 12. - Three-quarter rear view of airplane, showing location of air discharge louvers in the wing upper surface and exhaust discharge at the wing tip.

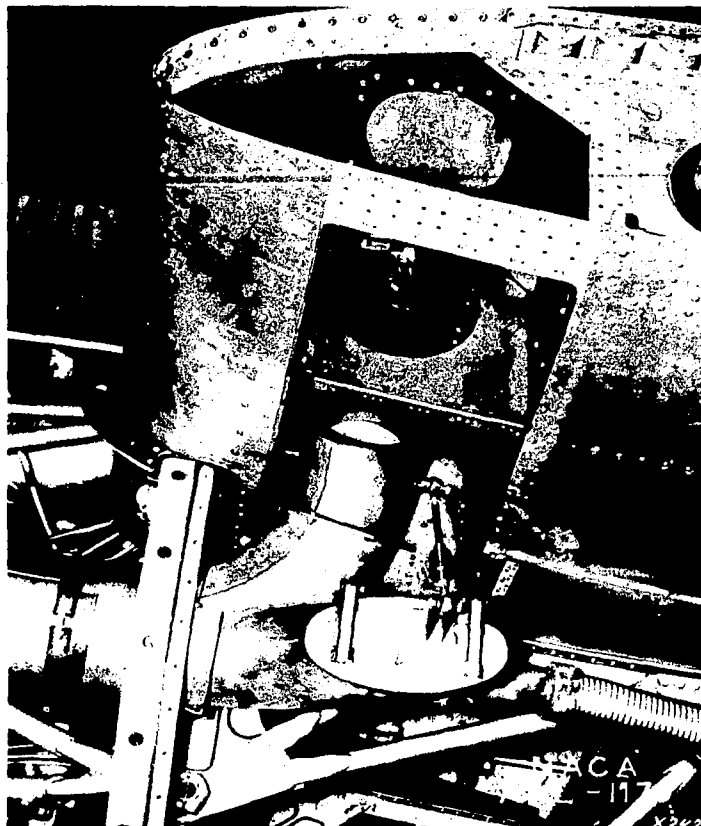
Figure 2. - Exhaust tail pipe showing "Y" and valve systems. When the valve over the normal discharge opening closes, a butterfly valve in the elbow opens permitting the exhaust gas to pass through the wing heating tube.

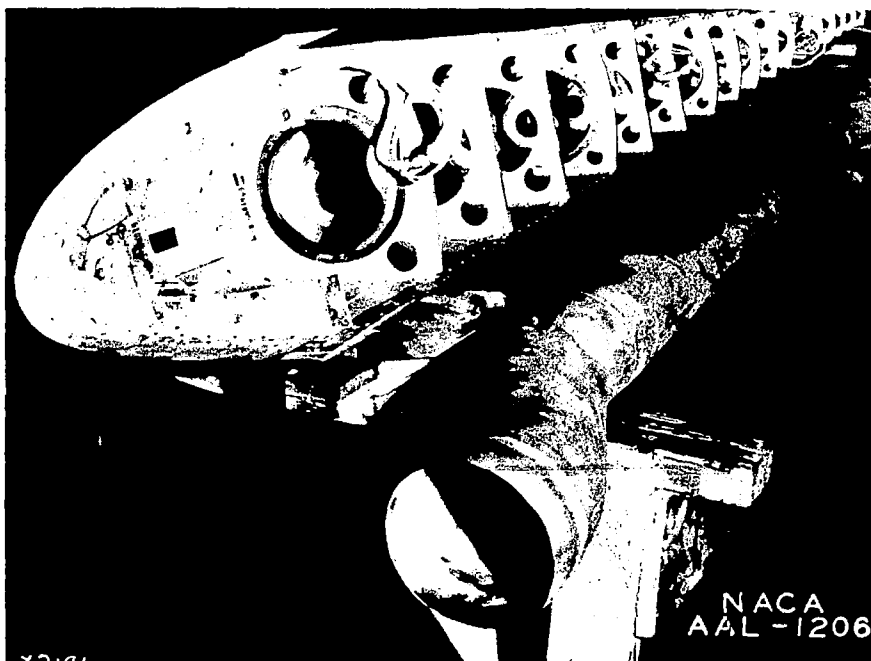
Figure 3. - Exhaust wing heating tube and wing leading edge shown disassembled.

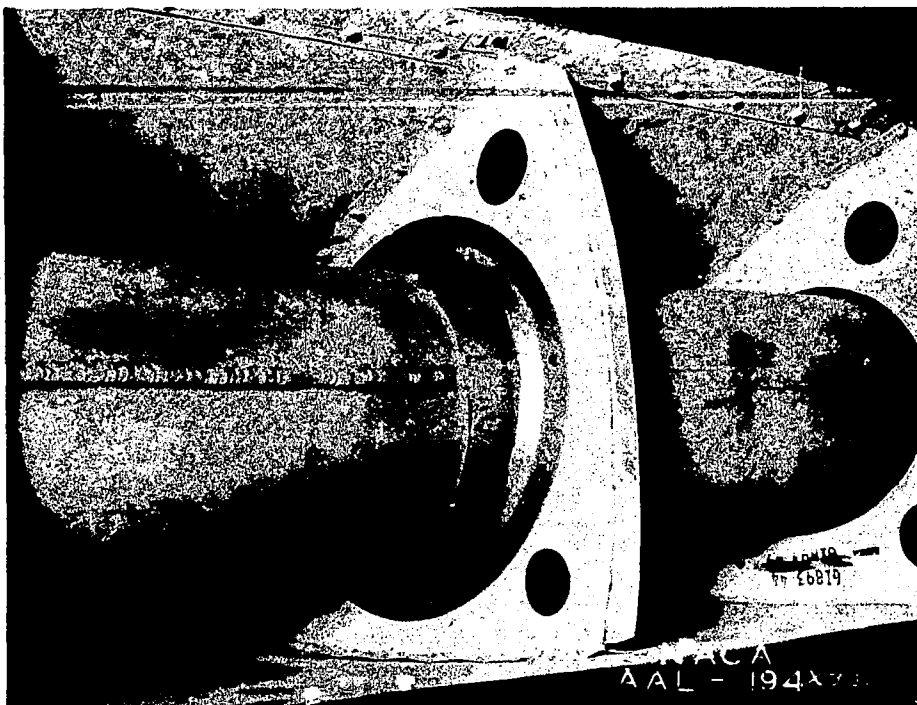
Figure 4. -

Exhaust wing heating tube in leading edge showing mounting ring and spring.

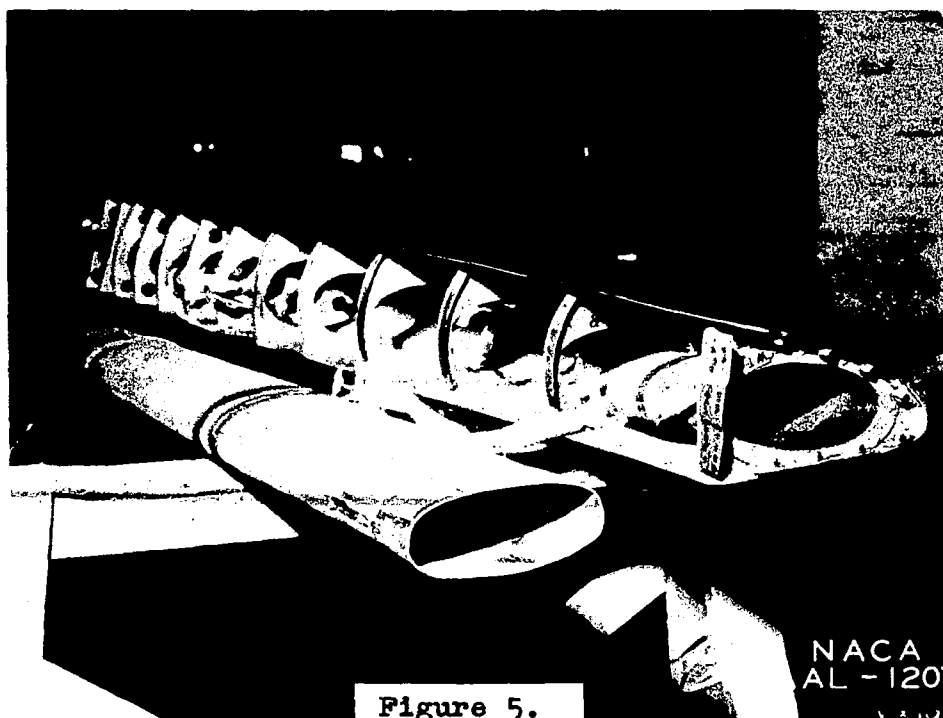
Figure 5.

Tip end of wing heating tube, shown disassembled with the leading edge.

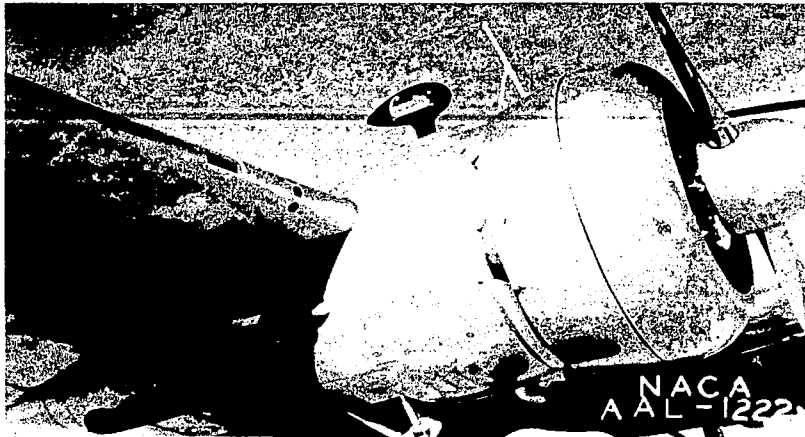
Figure 8. - A view of the wing leading edge showing the air intake port. The opening area of this port could be varied during flight by a control located in the pilot's cockpit.

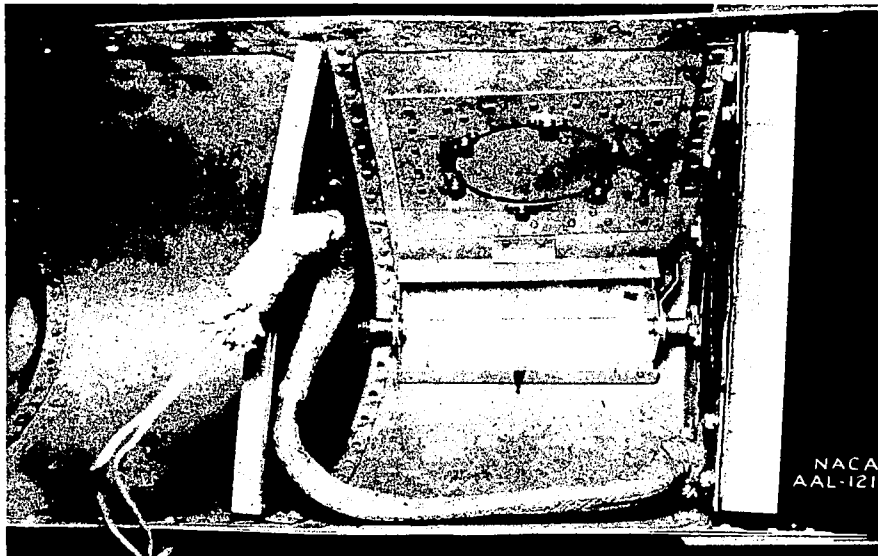
Figure 9. - Interior view of wing leading edge air intake port.

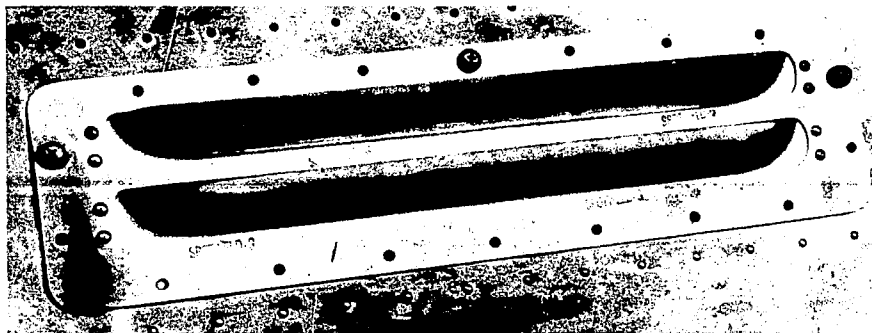
Figure 10. - Air outlet louvers, located on the upper wing surface. Two were employed on each wing, each located about 5 inches ahead of the rear wing beam.

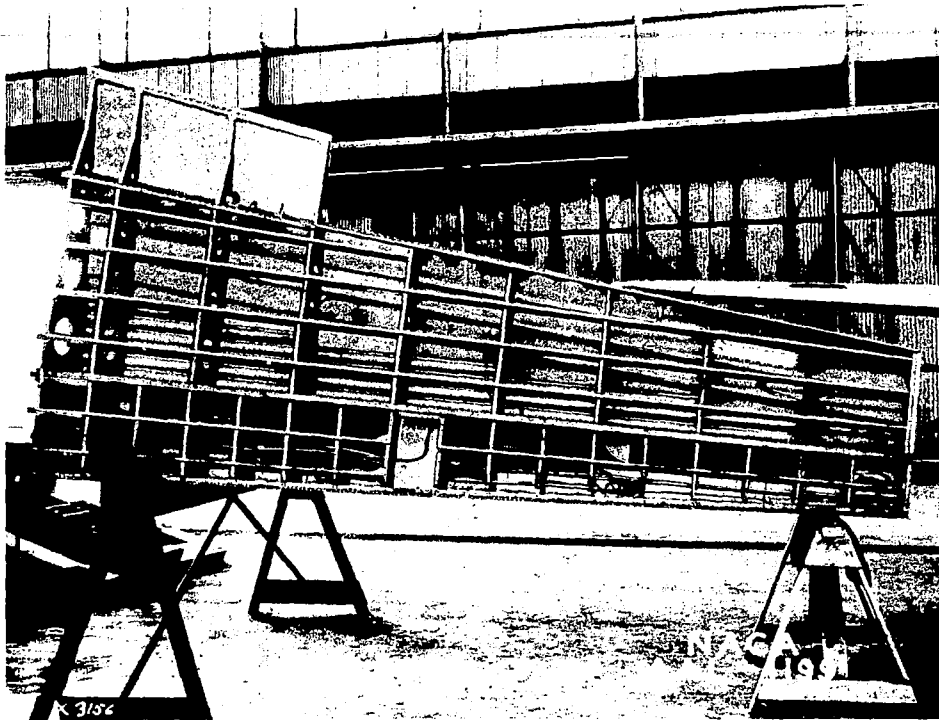
Figure 11.

Interior view of wing during construction. The position of the air discharge louvers are seen on the wing skin attached to the back side as shown in this photograph.

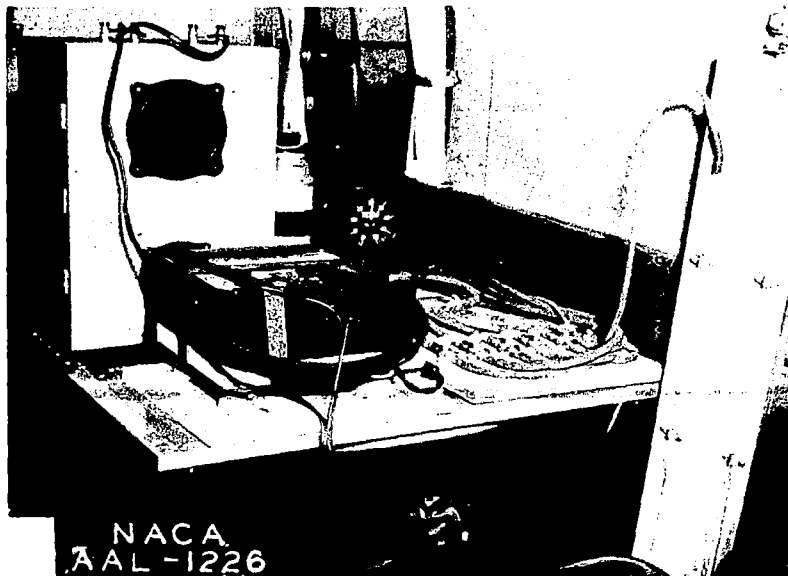
Figure 13.

Temperature and pressure measuring equipment in Lockheed 12-A airplane.

face of the wing, air was taken in through a port on the wing leading edge near the engine nacelle and passed along a circuitous route within the wing. After entering the leading-edge port, the air was passed along the space formed by the outside of the exhaust tube and the inside of the wing leading edge. After having been heated, as a result of passage along the leading edge of the wing, the air was run into the after-portion of the wing and finally discharged through louvers in the upper surface about 30 percent of the chord length ahead of the trailing edge. The quantity of air which was passed through the wing was controllable from the pilots' cockpit. Figures 8, 9, 10, and 11 show details of the air circulation system. The air-discharge louvers on the upper surface of the wing and the exhaust discharge at the wing tip are shown in figure 12. The heat was distributed over the span between the engine nacelles and the tips. Temperatures of the exhaust gas, gas duct, wing structure, wing skin, and circulated air were measured in flight by thermocouples. Pressures within the exhaust-duct system were measured at five points along the exhaust tube and manifold. Instruments and equipment for making the temperature and pressure measurements are shown in the airplane cabin in figure 13.

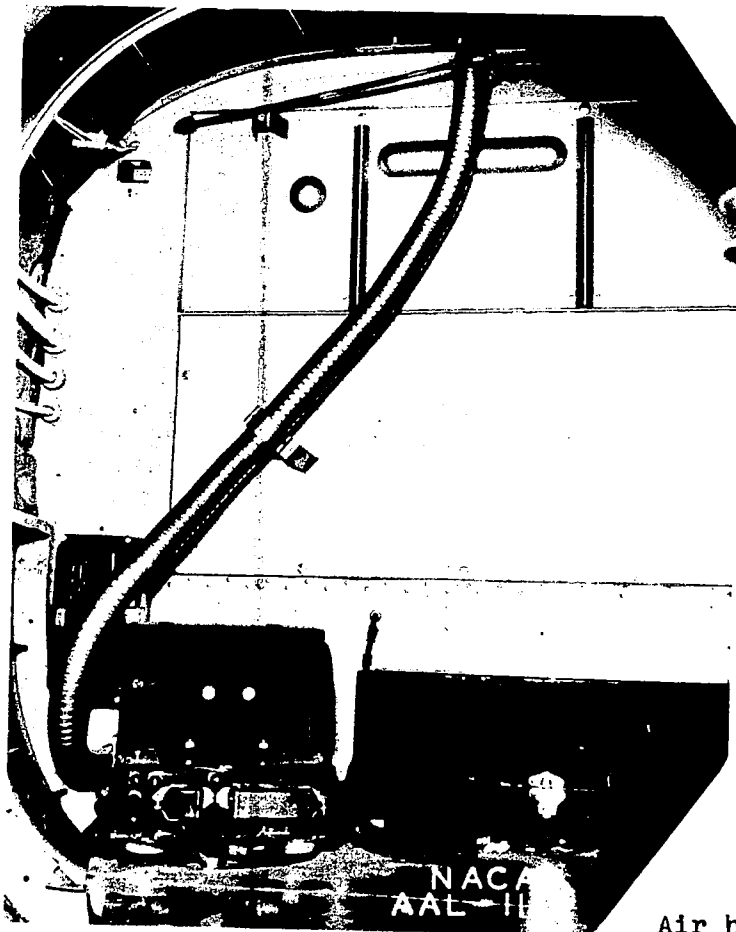
Figure 14.

Air duct and valve leading to the windshield hot-air manifold. This view is from the front end of the fuselage at the baggage door.

Heated air for the pilot's windshield was taken from the exhaust air heater of the right engine. The heated air was piped to a manifold at the windshield leading edge. Details of the air-duct system for the windshield are shown in figures 14 and 15. A control for the flow of heated air through the windshield was located in the pilots' cockpit. The windshield was composed of two panes

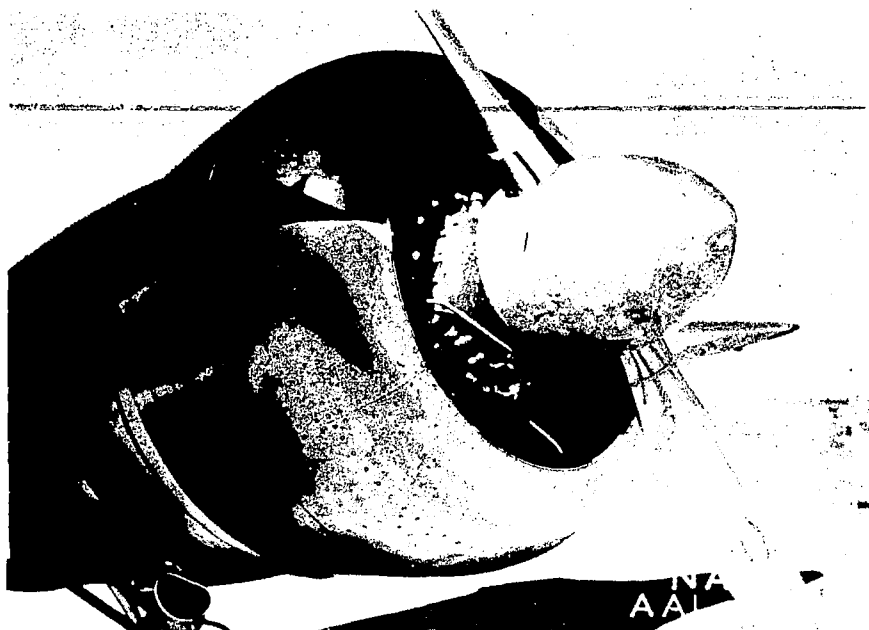
Figure 16.

Propeller anti-icing equipment. A rubber tube, conducting alcohol, discharges on the blade near the stagnation pressure line.

Protection against the formation of ice on the propeller blades was provided by the distribution of alcohol from a tube on each blade extending from the hub along the blade leading edge. The tubes, which were made of rubber, were lashed to the propeller blade near the stagnation pressure line. The propeller anti-icing fluid tube and attachment are shown in figure 16.

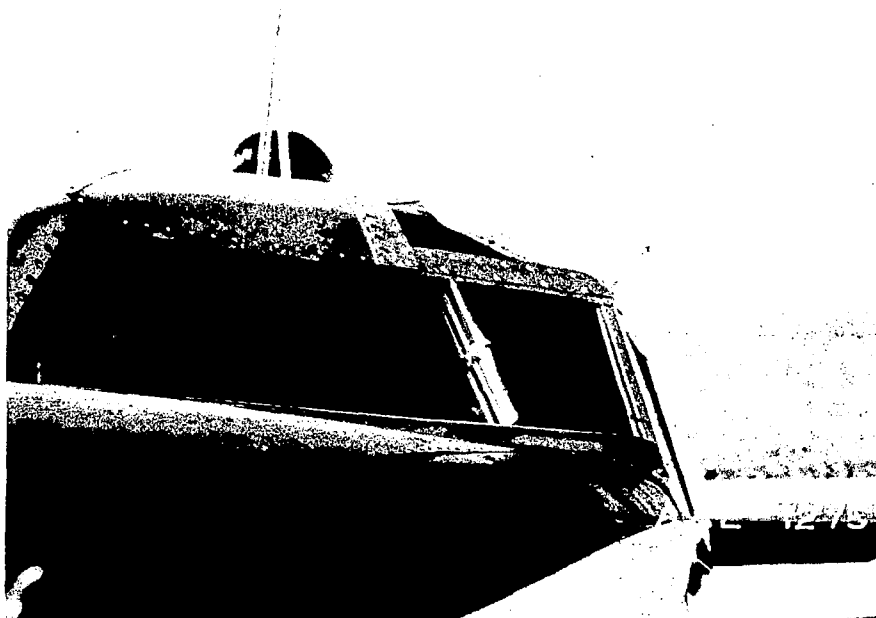
Figure 17.

Rotating windshield wiper mounted on pilot's windshield.

Additional protection of the pilot's windshield was sought through the use of a rotating windshield wiper. Alcohol was discharged from the hub of the wiper which was intended to prevent the formation of ice over the disk swept by the rotating blade. A view of the windshield wiper is shown in figure 17.

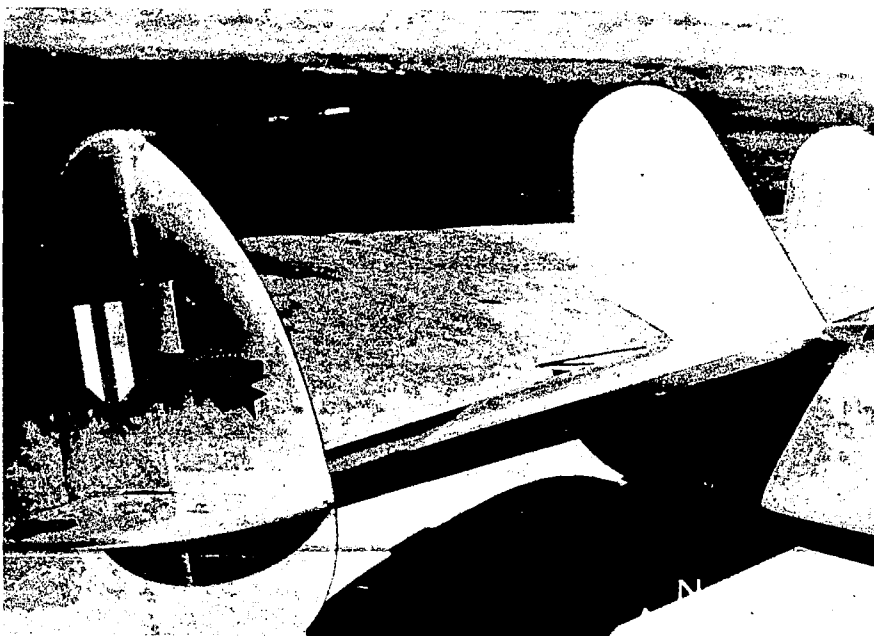
Figure 19. -

Goodrich inflatable de-icers on the Lockheed 12-A tail surfaces.

The leading edge of the horizontal stabilizer was equipped with a Goodrich inflatable de-icer. The de-icer was a two-lobe type and was designed with a rubber flap extending from the de-icer to the rear edge of the fairing strips. The de-icer installation is shown in figure 19.

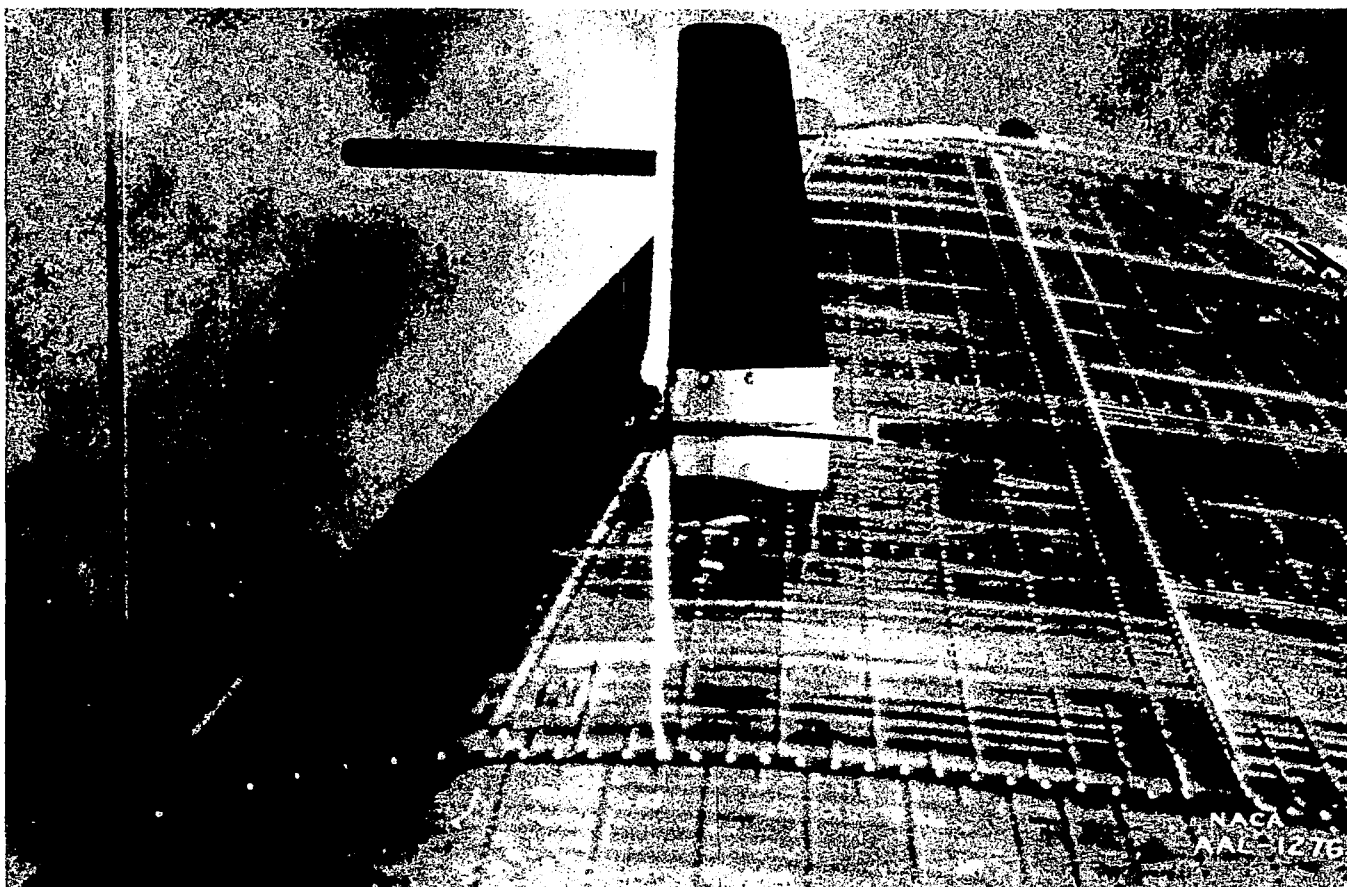
Figure 21.

A photograph taken on an icing flight during which ice was prevented on the airplane wing and pitot-static head by the use of exhaust heating. Ice on the tell-tale strut gives an indication of the nature of the icing conditions.

Data: Airspeed, 140 m. p. h.; altitude, 8,000 to 13,500 feet; Cumulus-Nimbus clouds; air temperature  $-10^{\circ}$  to  $22^{\circ}$  F.; air moderately to severely rough; types of ice, rime, glaze, and snow slush; estimated rate of icing, 6 to 7 inches per hour. The flight was made between Tacoma, Washington, and the Pacific Coast.

The heat which was supplied to the wing by the exhaust duct along the leading edge successfully prevented the formation of ice on all flights. Figures 20, 21, and 22 show photographs of the wing which were made during icing flights. Data which describe the conditions encountered during the flights are shown with the photographs. When icing conditions were encountered with air temperatures below  $0^{\circ}$  F, a tendency for ice to form around the air intake on the wing leading edge was observed. Under similar conditions, or when the wing heating system was operated on less than full heating capacity, thin sheets of ice about 1/16 inch thick formed on the wing surface in the vicinity of the trailing edge. The nature of the formation of ice along the unprotected wing leading edge between the fuselage and engine nacelle is shown in figure 23.

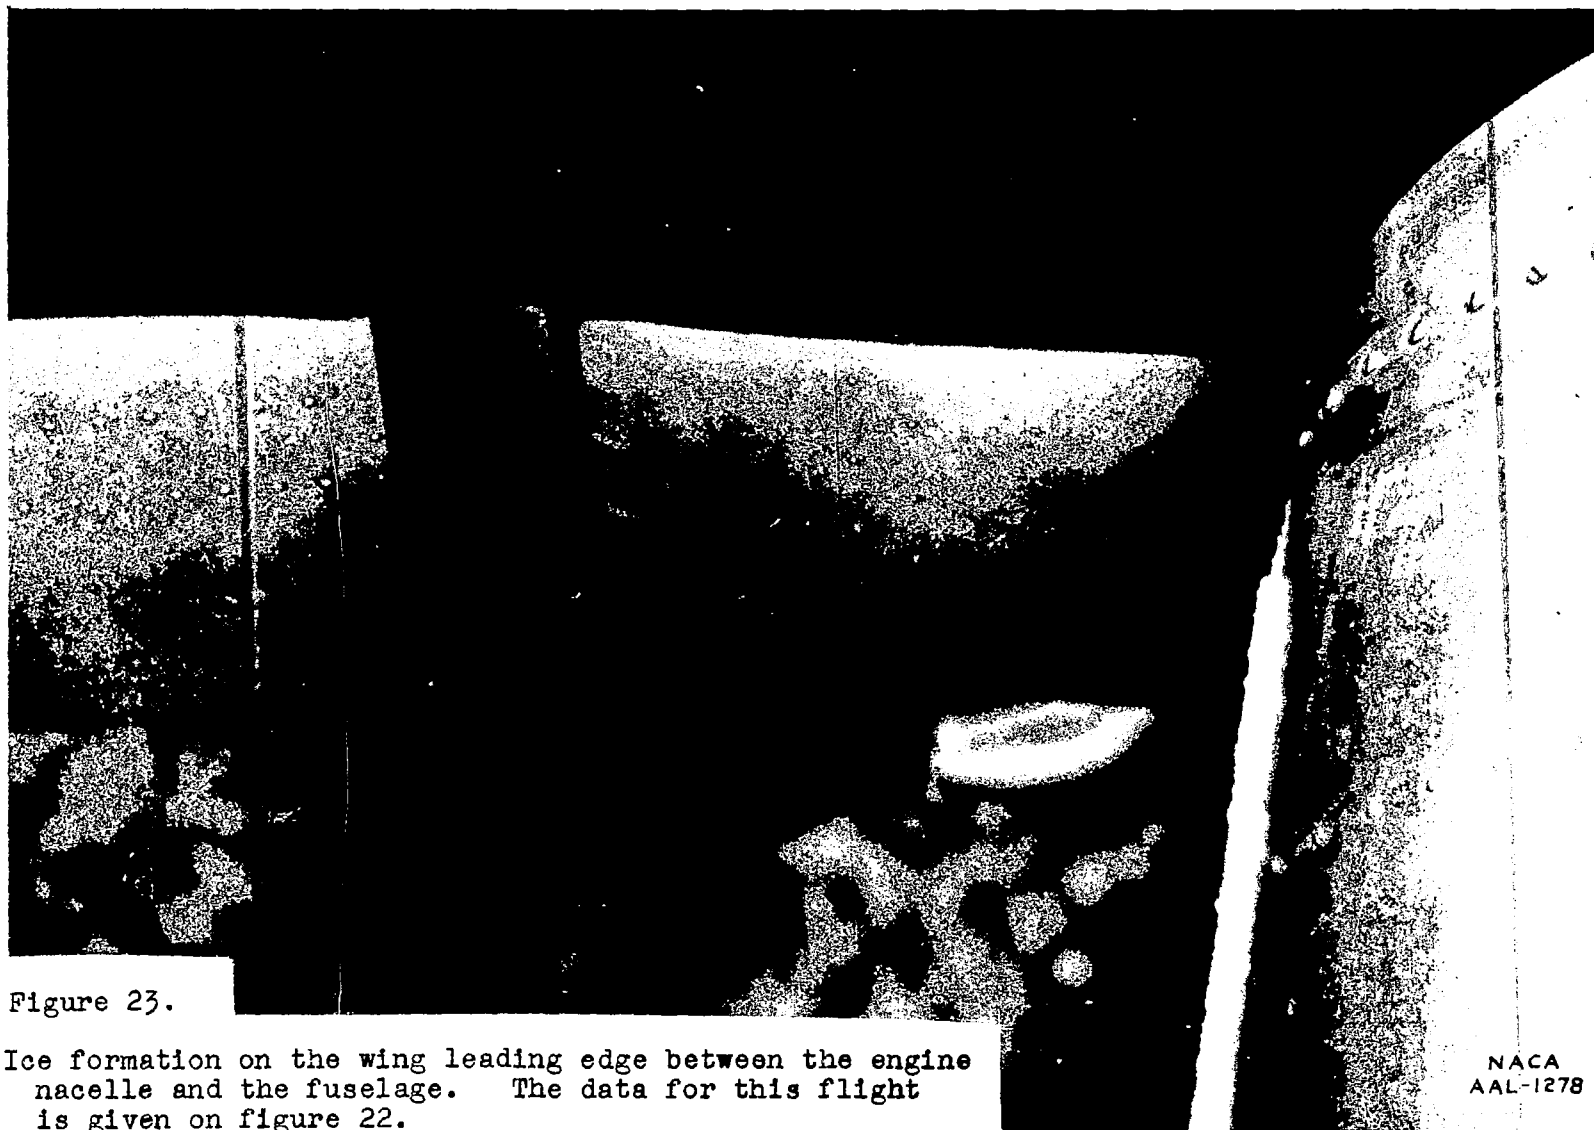
Figure 23.

Ice formation on the wing leading edge between the engine nacelle and the fuselage. The data for this flight is given on figure 22.

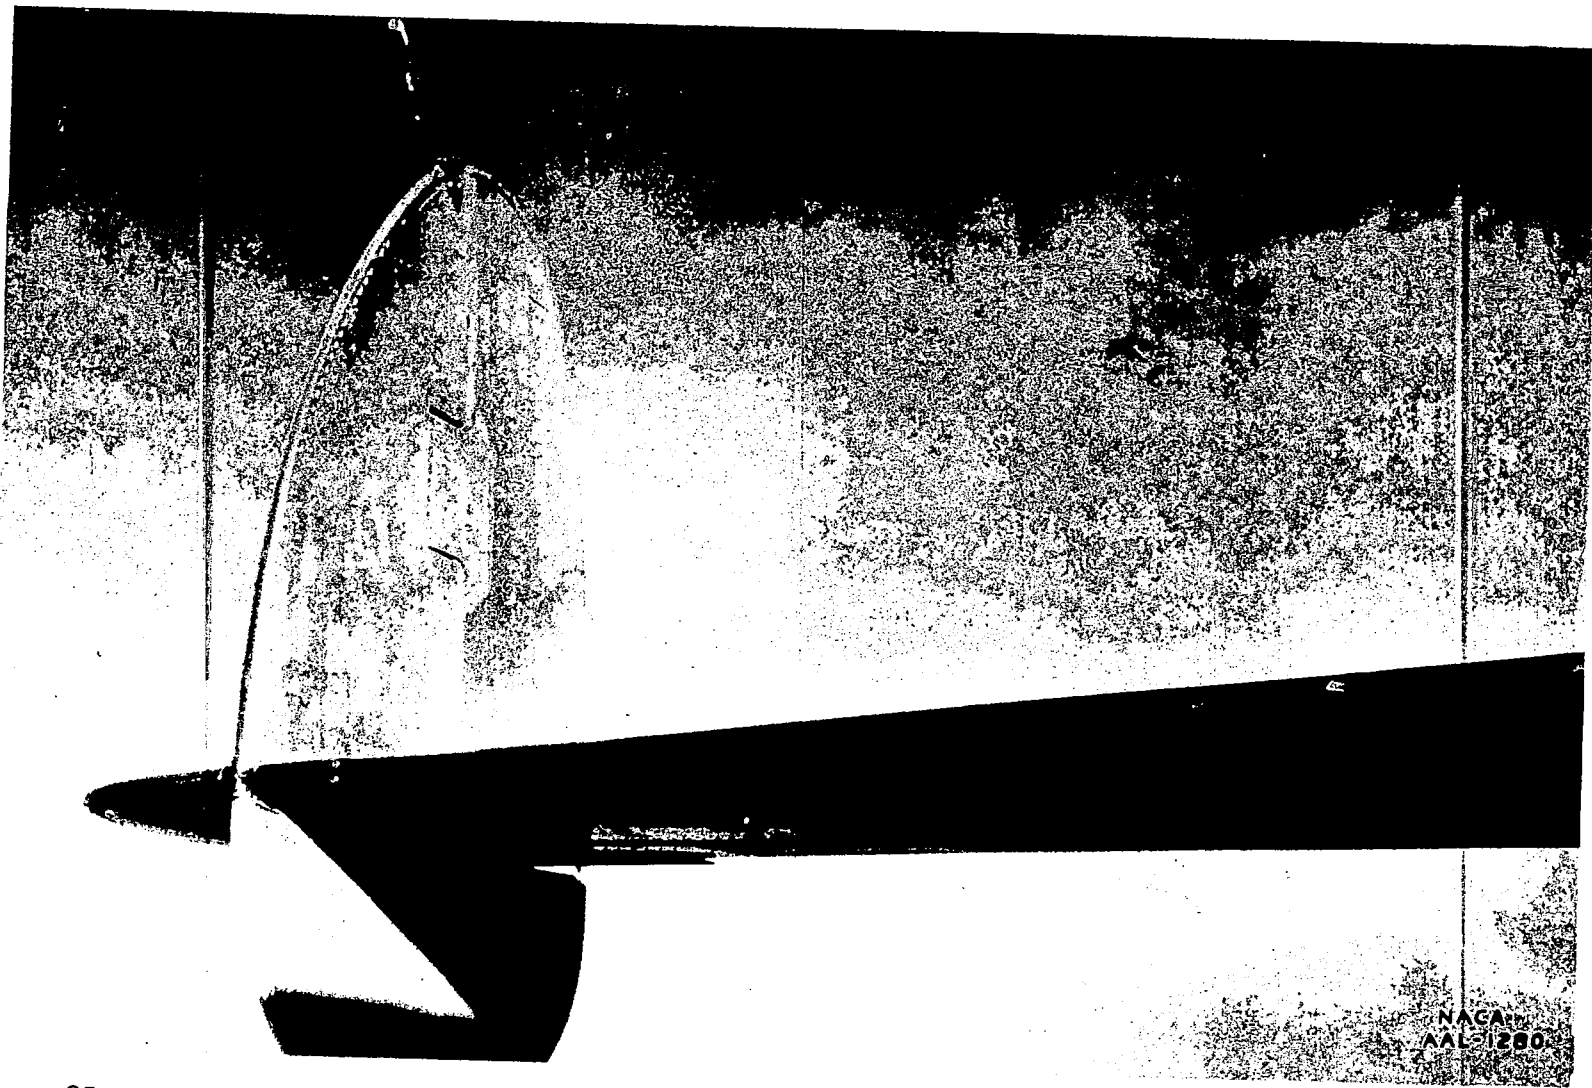
Figure 25. - The inflatable de-icer on the horizontal stabilizer of the Lockheed airplane after having been placed in operation. The data for this flight is found on figure 21. The photograph was taken during the early part of the flight.

Ice removal was only partially successful on the horizontal stabilizer on which the inflatable de-icer had been installed. It was observed that if the ice formation was hard and confined to the leading-edge region, upon inflation of the lobes of the de-icer the ice would break into many pieces and blow away. However, if the ice extended rearward over the surface or was inclined to have a soft consistency, the inflation of the lobes would break the ice only slightly and much of the ice would remain on the wing leading edge. Figures 25 and 26 show the ice accretion remaining on the leading edge of the stabilizer after the inflatable de-icer had been operated during one flight.

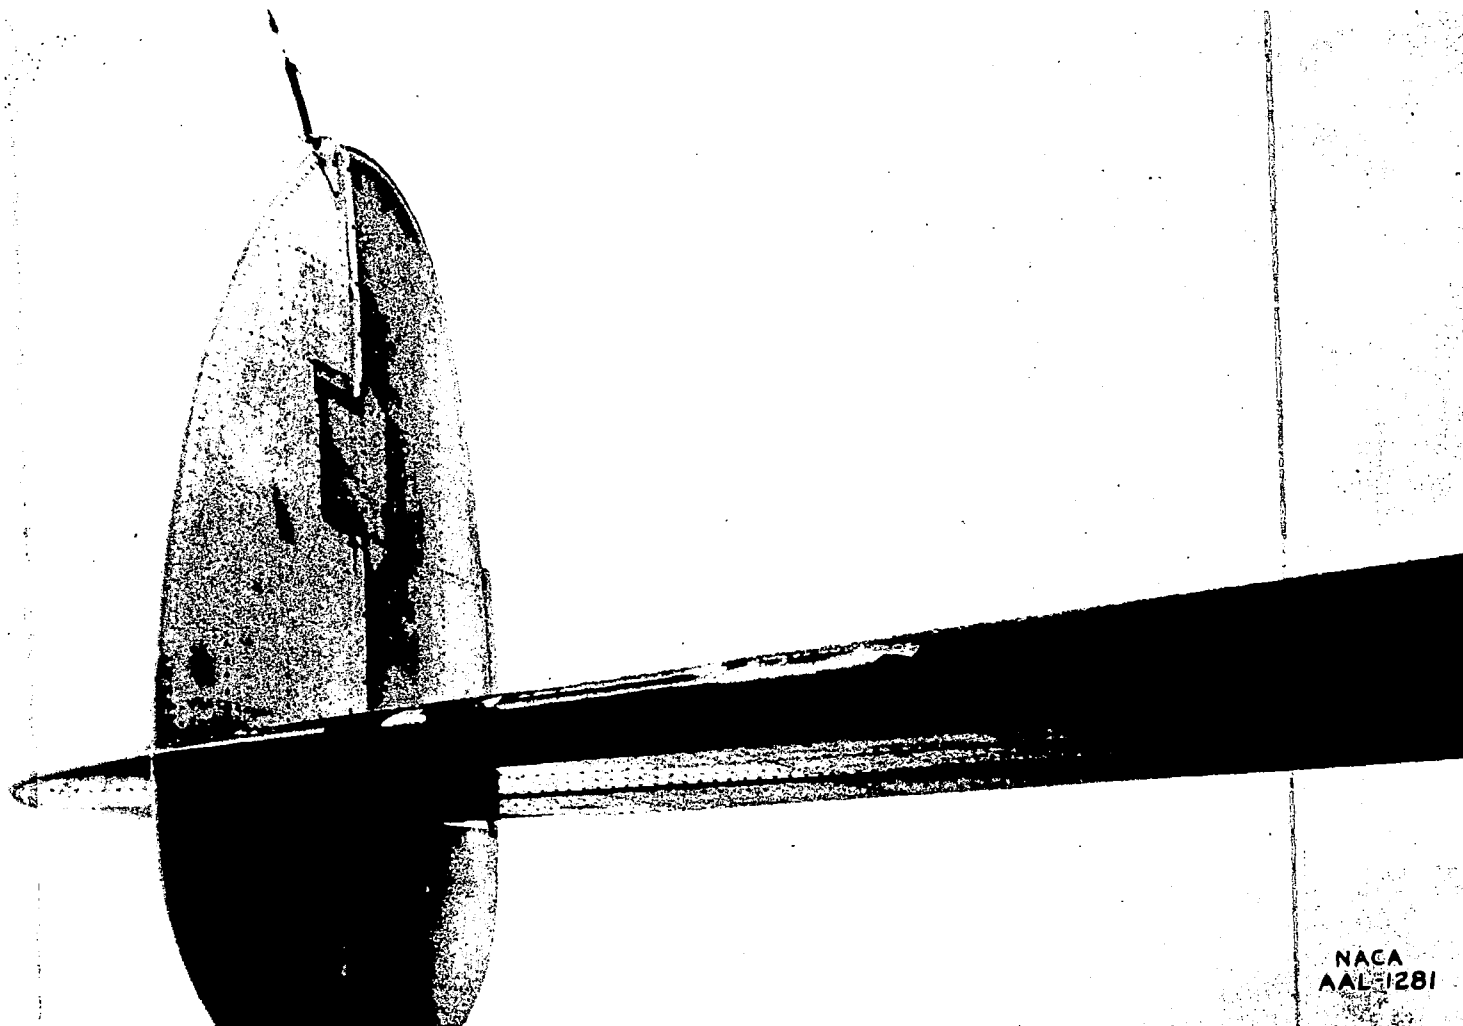
Figure 26. - A photograph of the de-icer on the Lockheed tail which was taken a few minutes after the photograph shown in figure 25. Residual ice remained on the stabilizer leading edge throughout the flight.
